NIST GCR 98-757

Guide to Improved Earthquake Performance of Electric Power Systems

Anshel Schiff
Stanford University

September 1998

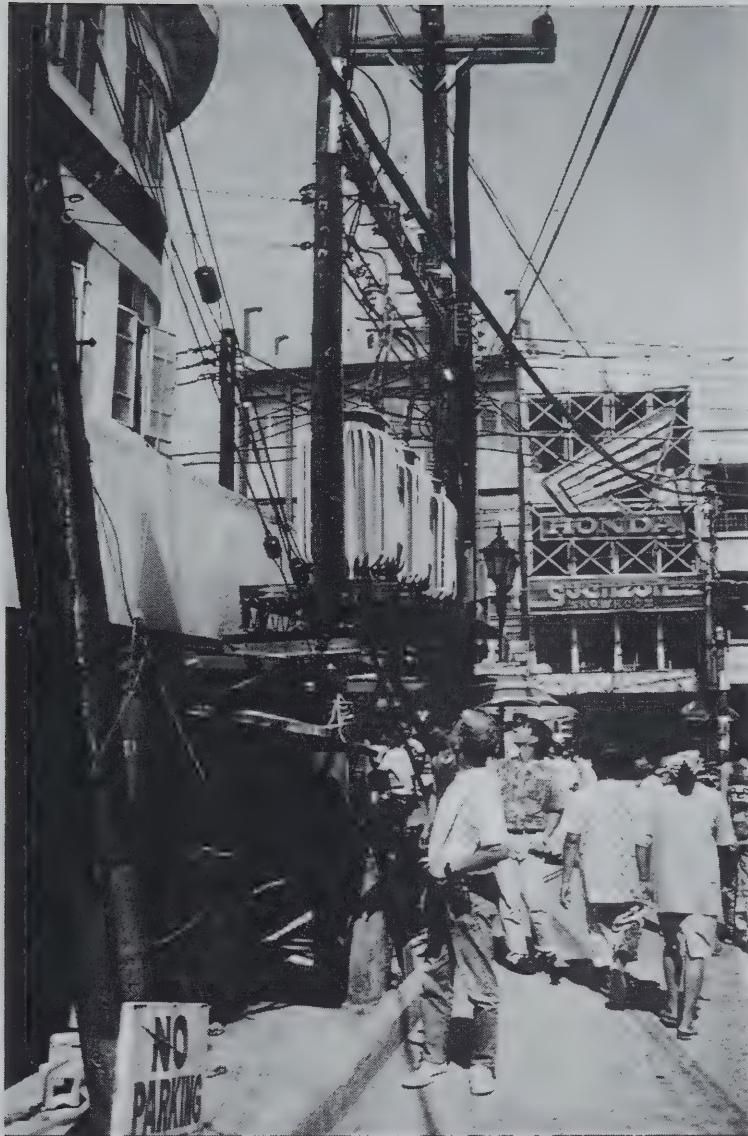
Figure 5.80. Platform-mounted transformers are used by some utilities in congested urban areas because land for a vault is not available or is very expensive. Should these units fall they present a hazard.

Figure 5.80 The poles supporting these transformers sank into the liquefied soil several feet so that a pedestrian could reach up and touch the transformers from the roadway.

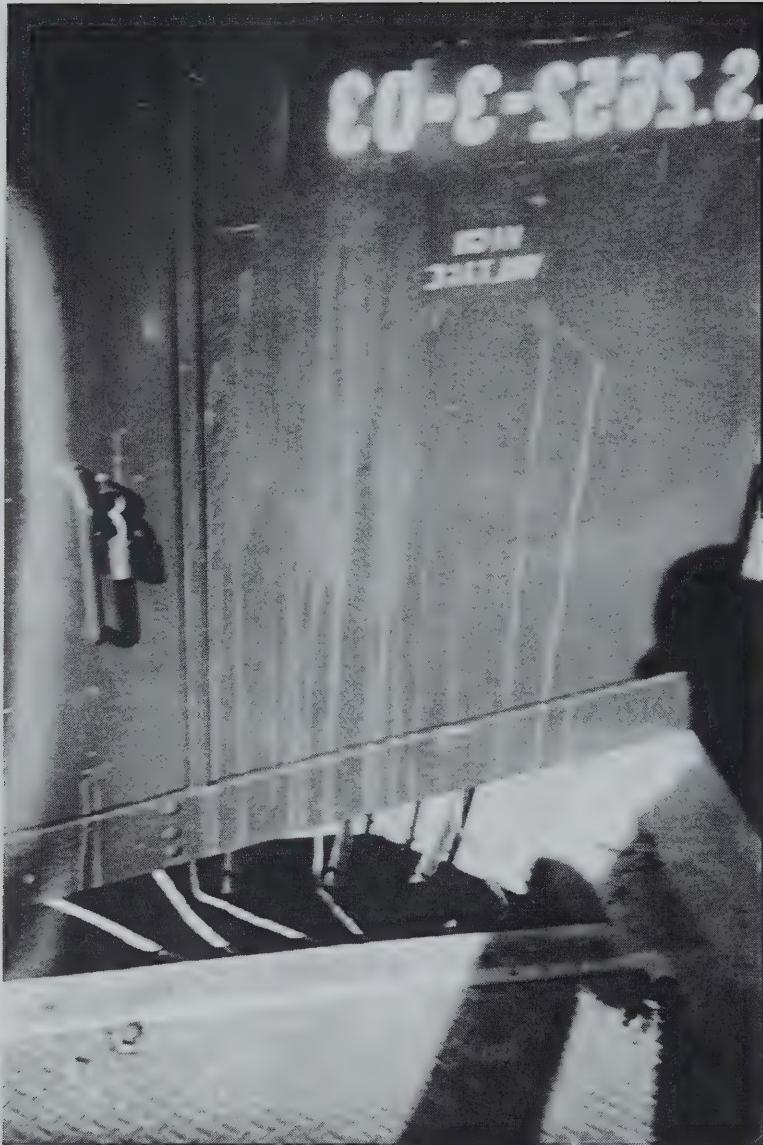
Figure 5.81 Slab-mounted distribution transformer was unanchored and slid on its slab.

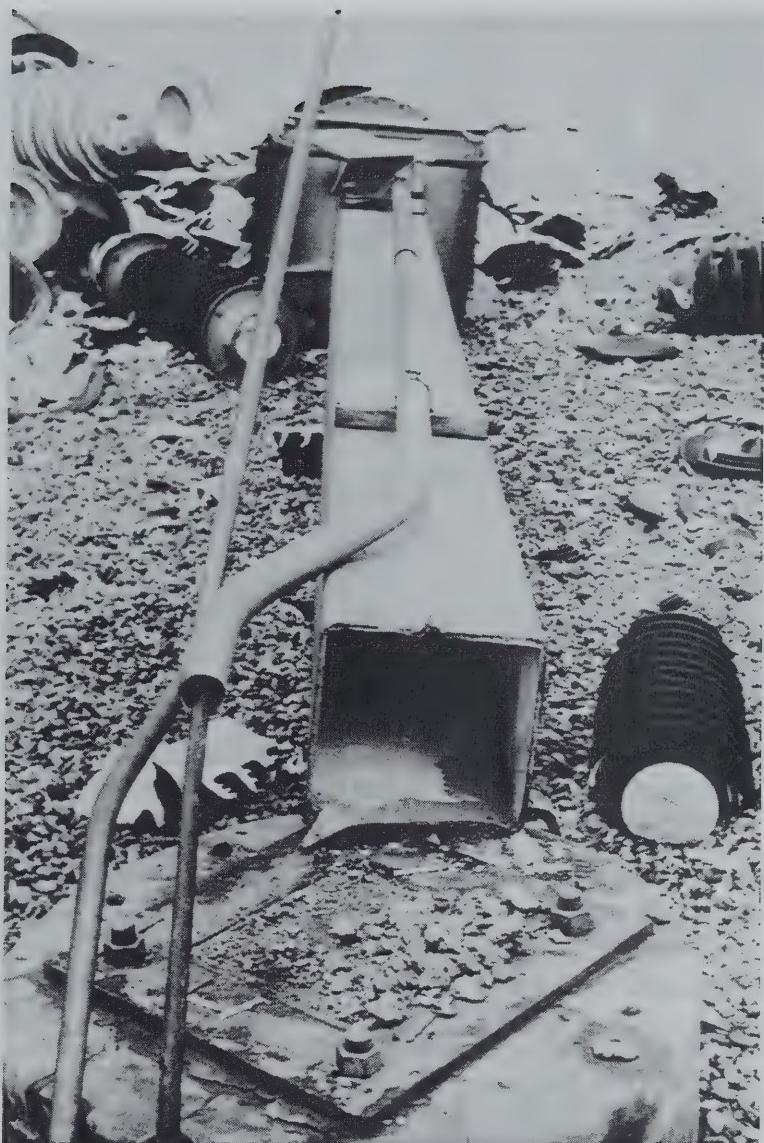
Figure 5.86 A post fell over when the weld between the base plate and post failed.

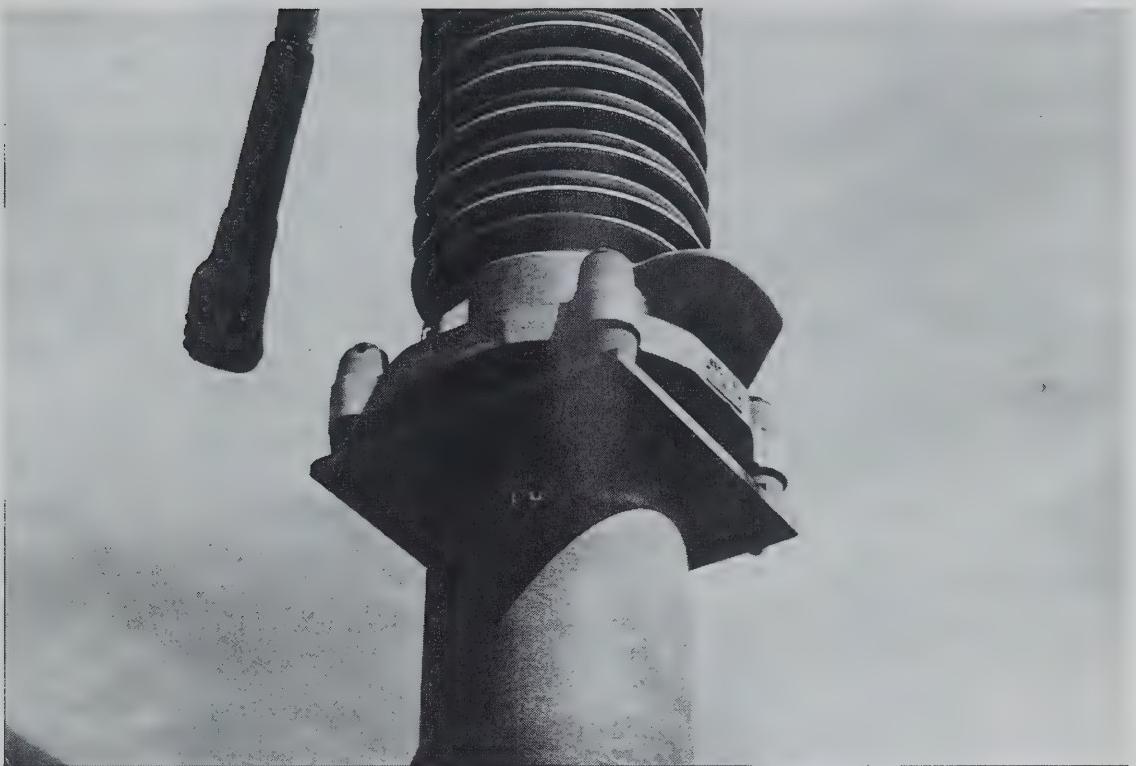
Figure 5.91 Standoff design puts porcelain under compression and the bolt carries tensile loads.

About half of the lightning arrester failures are due to the failure of standoffs. They should not be used unless a strike counter is needed. Standoffs have two designs. Those shown in Figure 5.77 consist of porcelain with a stud protruding from each end. When installed and under load, the axial load to resist overturning moments must be carried by the porcelain in tension. Figure 5.91 shows another design. The porcelain members sandwich the anchor tab of the lightning arrester. A bolt passes through holes in the porcelain, and anchor plate at the top of the support post. In this configuration the bolt carries the tensile loads and the porcelain is under compressive loads. No failures have been observed in this type of standoff.

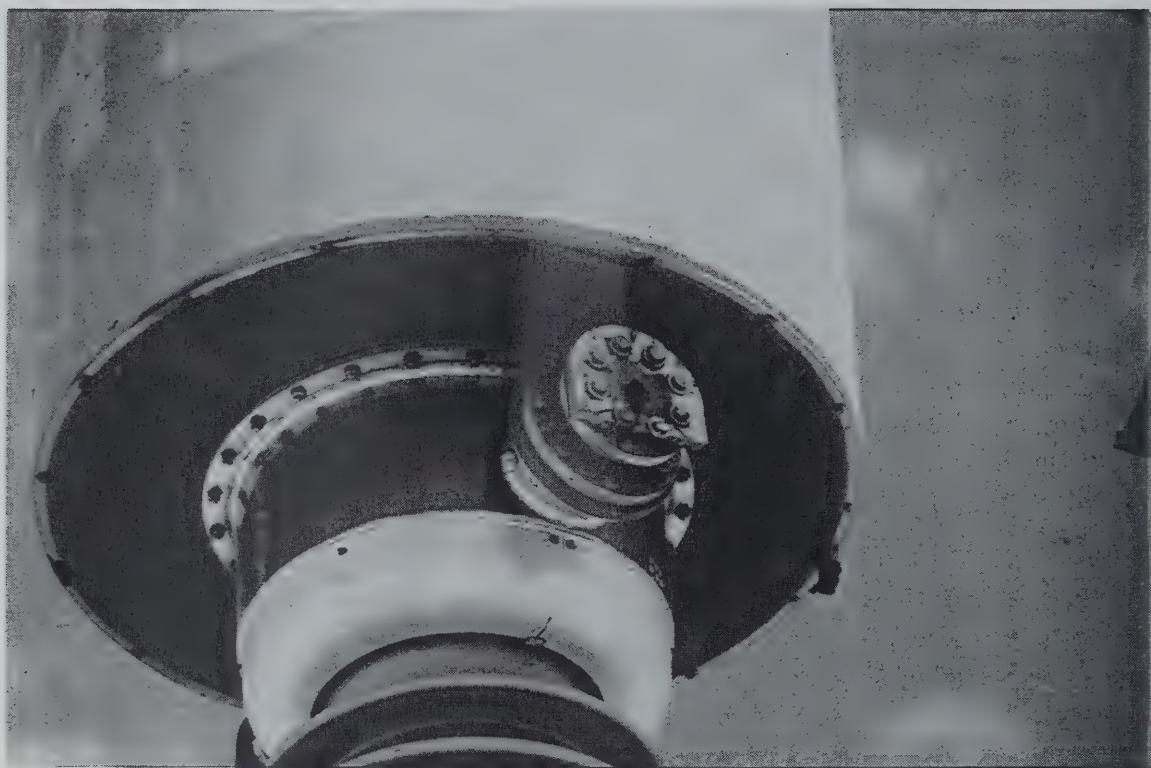
Figure 5.94 The cast aluminum cable connection failed.

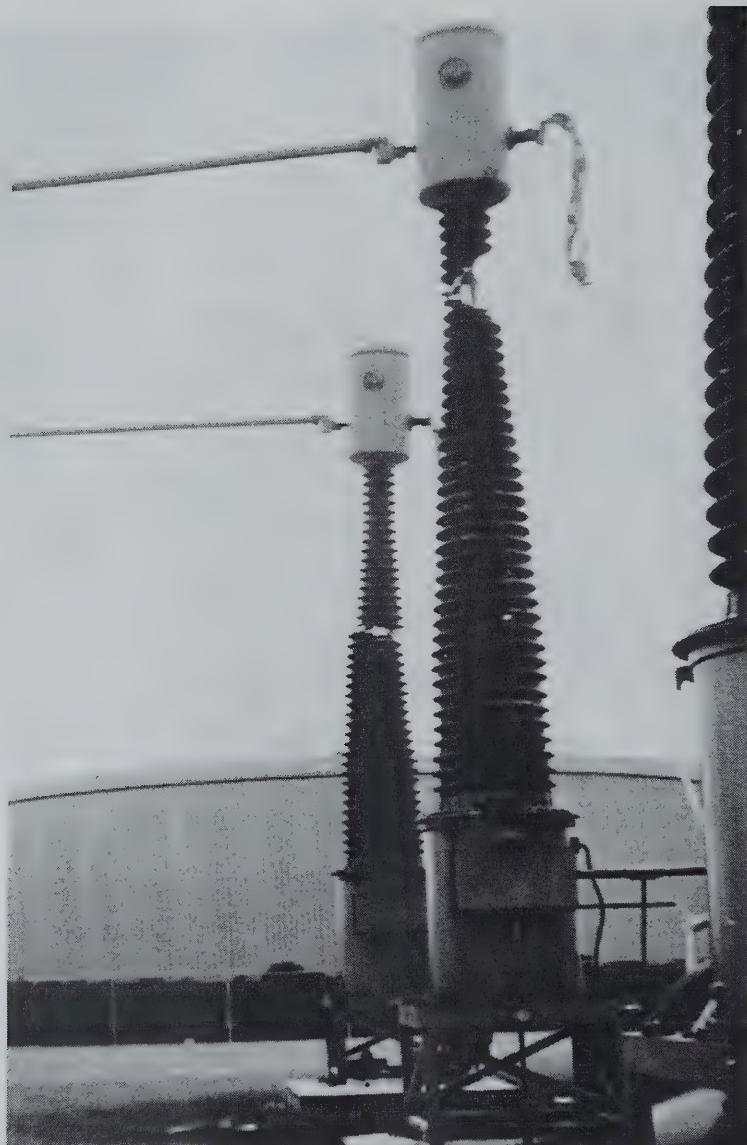
Figure 5.98 shows damaged current transformers resulting from the failure of live-tank circuit breakers. The conductors seen hanging from the current transformer had been retrofitted to provide flexible connections, but the collapse of the circuit breakers made excessive demands. Note that the conductor hardware failed, but not before damaging the current transformer.

Figure 5.98 Collapse of the live-tank circuit breakers damaged the adjacent current transformers.

As can be seen in Figure 5.98, generous slack will not prevent damage if equipment collapses. An alternative is to incorporate a breakaway connection to isolate adjacent pieces of equipment. This is what happened with the connection shown in Figure 5.94, but in this case the connection was not an engineered breakaway connection and the failure load still caused damage to the equipment. These issues are discussed in Sections 5.6.4 and 5.6.6.

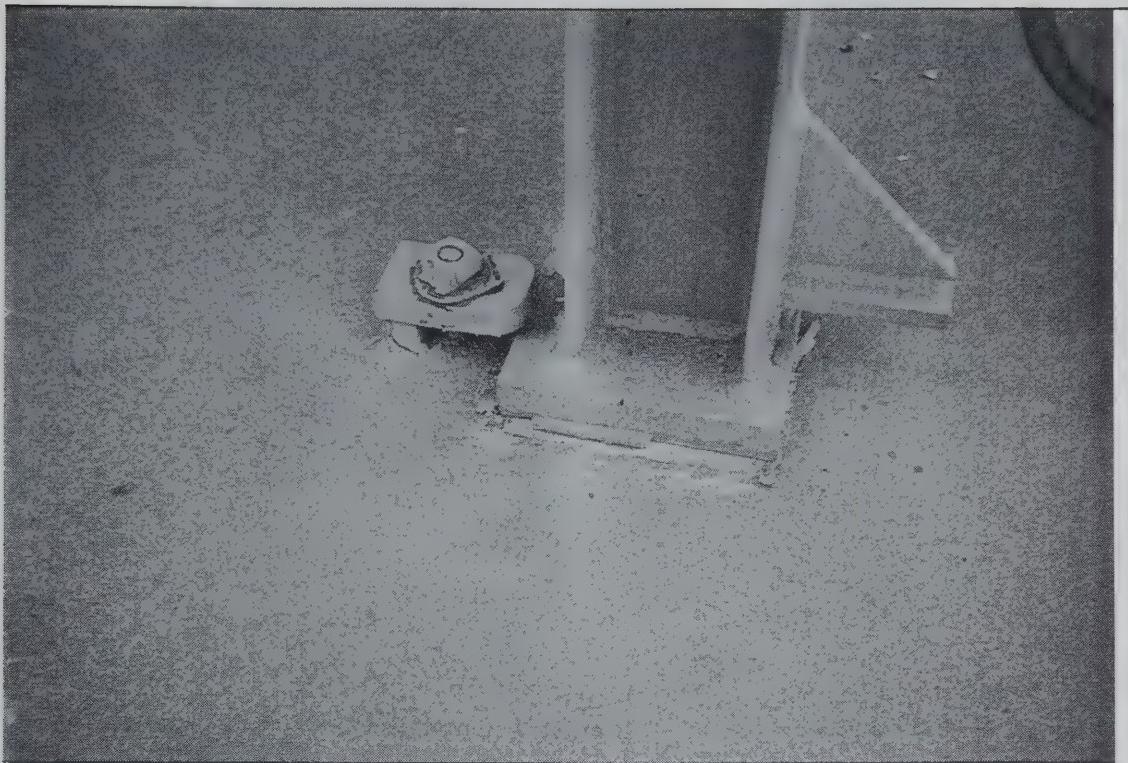
Figure 5.111 Friction clips used to secure a circuit breaker allowed the circuit breaker to lift off of the foundation slab. Impact loads when the unit fell back to the slab could have contributed to the failure.

Friction clip anchors not only allow circuit breakers to fall over, but may also contribute to porcelain failure by allowing impact loads to be generated. Welding the friction clip to the flange that it is clamping can eliminate this and other problems.

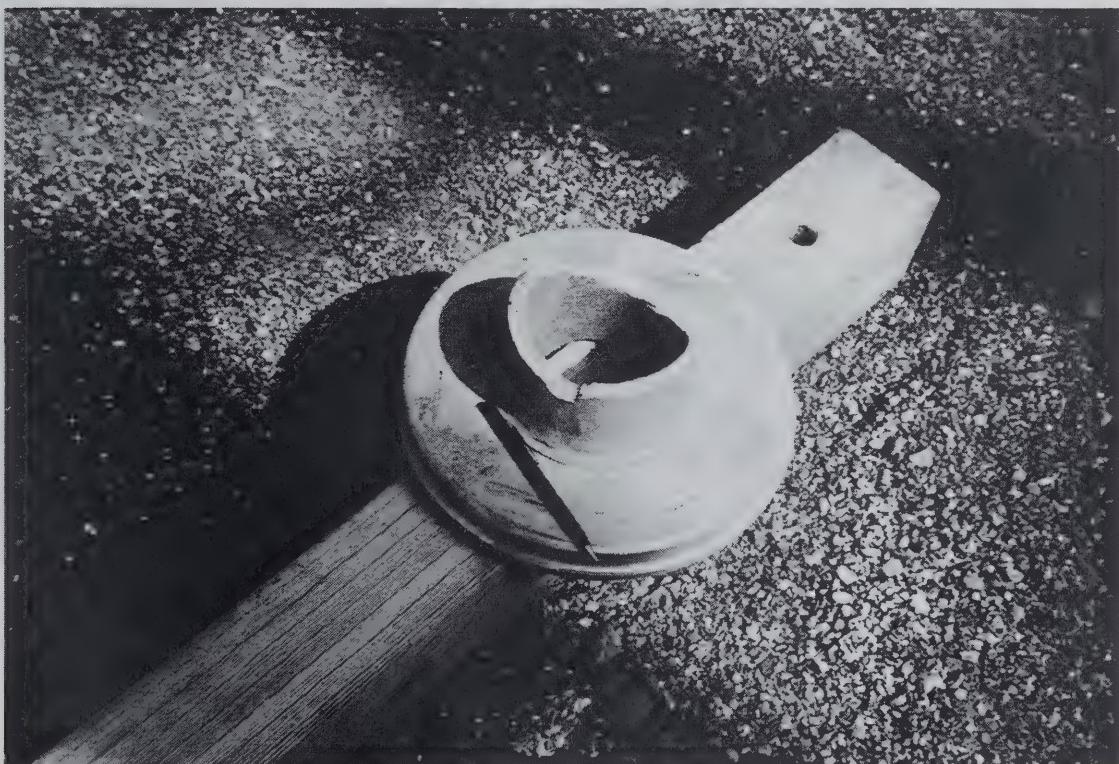
head and the failed aluminum casting. The brittle failure of the casting may have started at a hole in the casting that acted as a stress raiser.

Figure 5.119 Aluminum casting supporting the interrupter head had a brittle fracture failure.

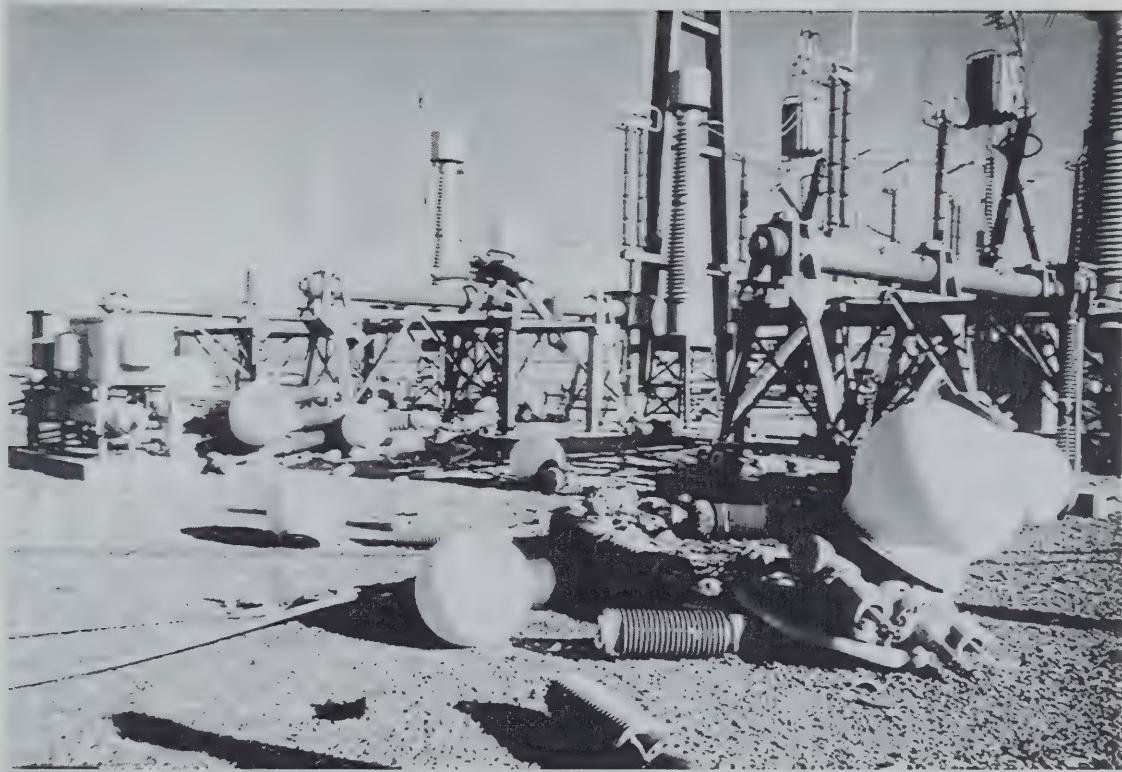
Figure 5.121 shows the damaged circuit breaker before it was replaced by the unit shown in Figure 5.120. While the ground motions at the site were large, this circuit breaker had been qualified by analysis based on response spectra anchored at 0.5 g. The circuit breaker support structure used bolted connections with slotted holes. An evaluation after the earthquake showed that the zinc protective coating around the holes had been burnished by the back and forth action of the bolt in the slot. When a bolt is suddenly stopped at the end of a slotted connection, impact loads are introduced to the structure and the equipment it supports. This may have contributed to the equipment damage.

Figure 5.121 The damaged circuit breaker before it was replaced by the unit shown in Figure 5.120.

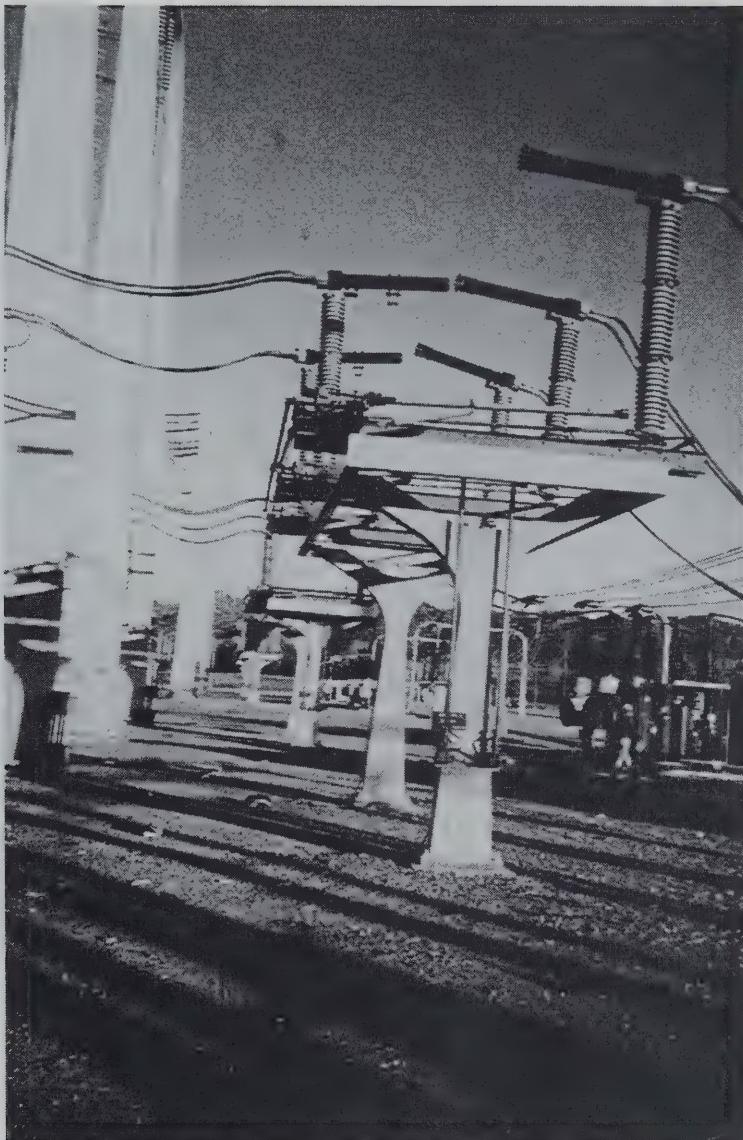
Several failures of disconnect switches not related to the fracture of porcelain have been observed. Many of the center-break type switches at a substation had the cast aluminum plates that support the post insulator deform so that when the switches were operated to the closed position the contact surfaces would remain open, Figure 5.124. This failure was due to the deformation of the cast aluminum plate that supported the post insulators, Figure 5.125. Burning of the contacts on closed center-break disconnect switches has also been observed, probably due to the movement of the contacts during the earthquake. This of course would not occur if the switches were open.

Figure 5.124 Center break disconnect switch contacts remained open when the switch was operated to the closed position due to the deformation of the plate supporting the post insulators.

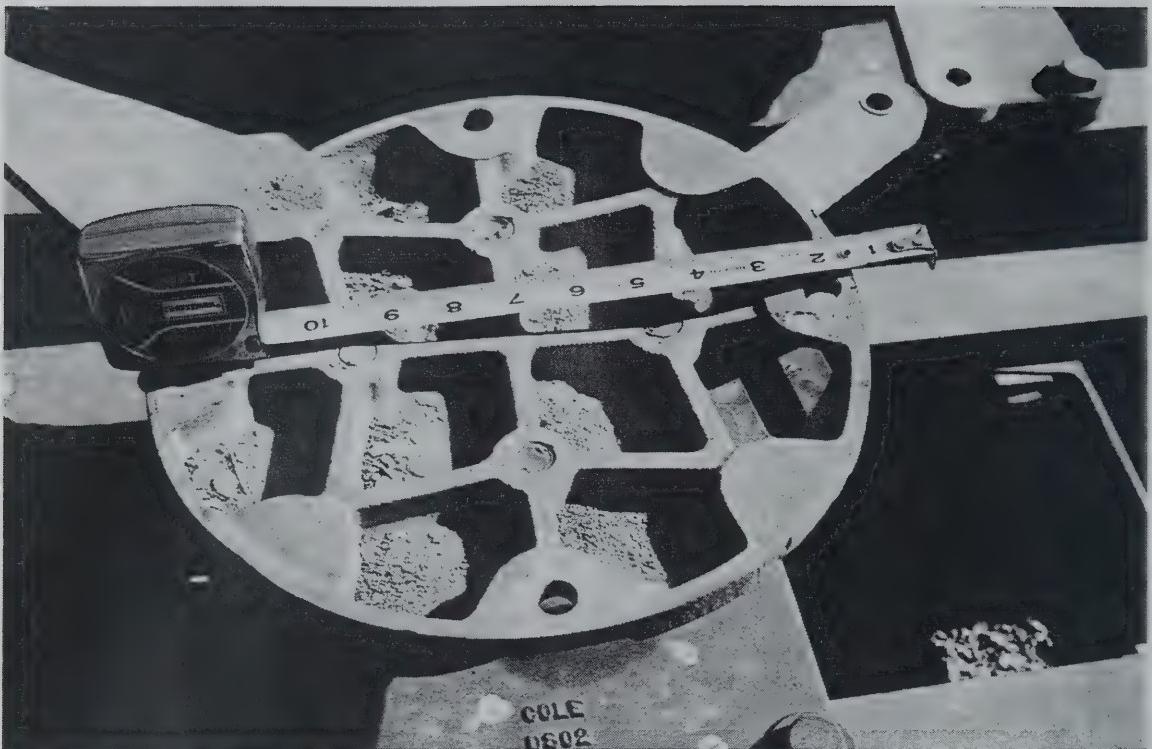
Figure 5.125 The deformation of the cast aluminum base plate prevented the disconnect switches from closing properly.

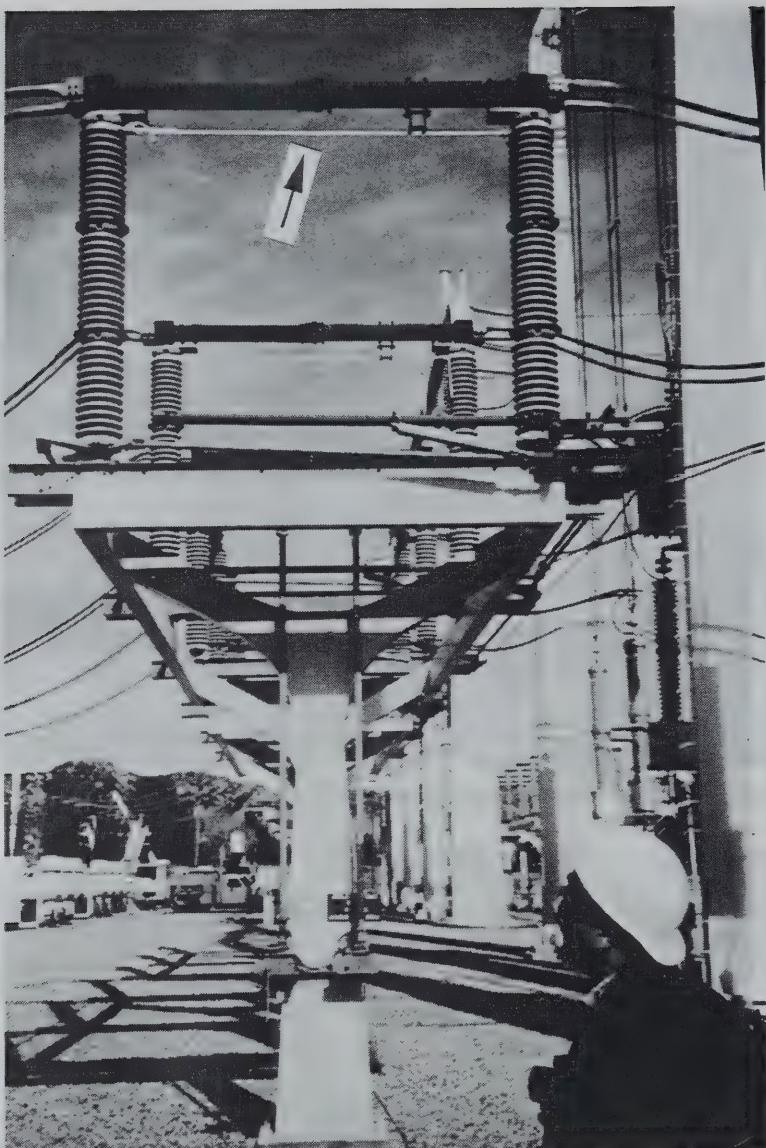
Figure 5.128 Cotton rope was used to keep deformed disconnect switches shown in Figure 5.124 closed so that service could be quickly restored.

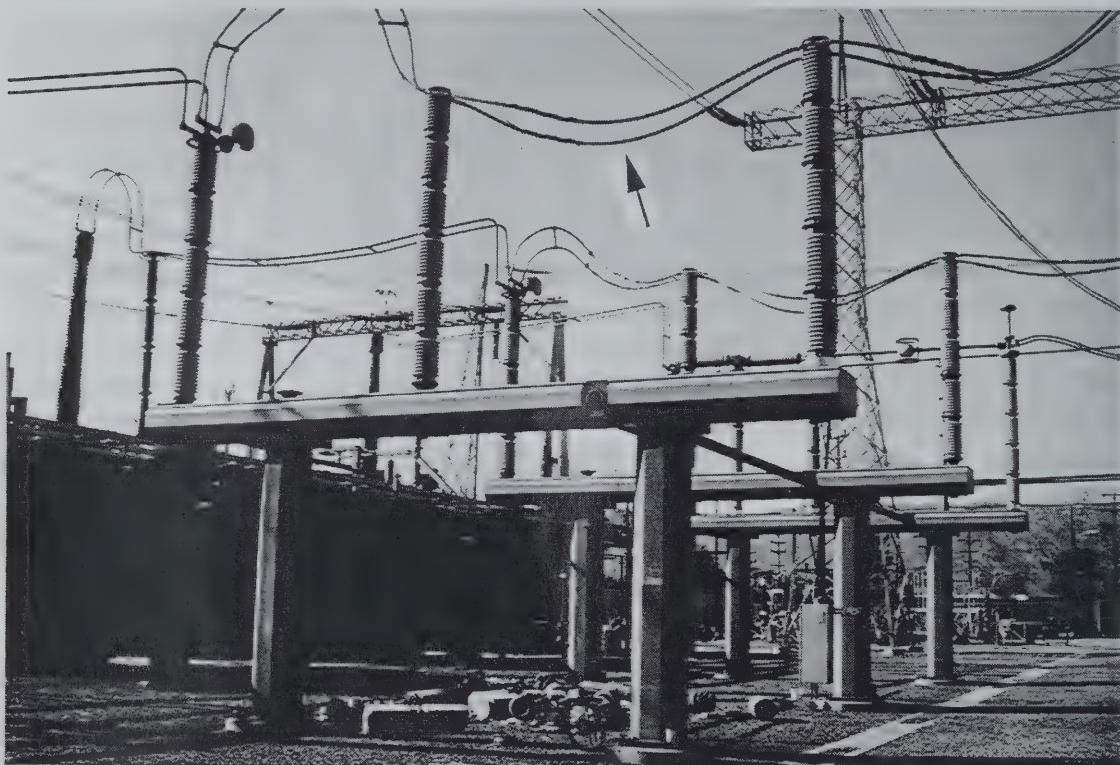
Figure 5.130 shows temporary conductors used to bypass the circuit switcher. The conductor was supported on remnants of the original columns and on post insulators that replaced some damaged columns.

Figure 5.130 A damaged circuit switcher temporarily bypassed to restore service.

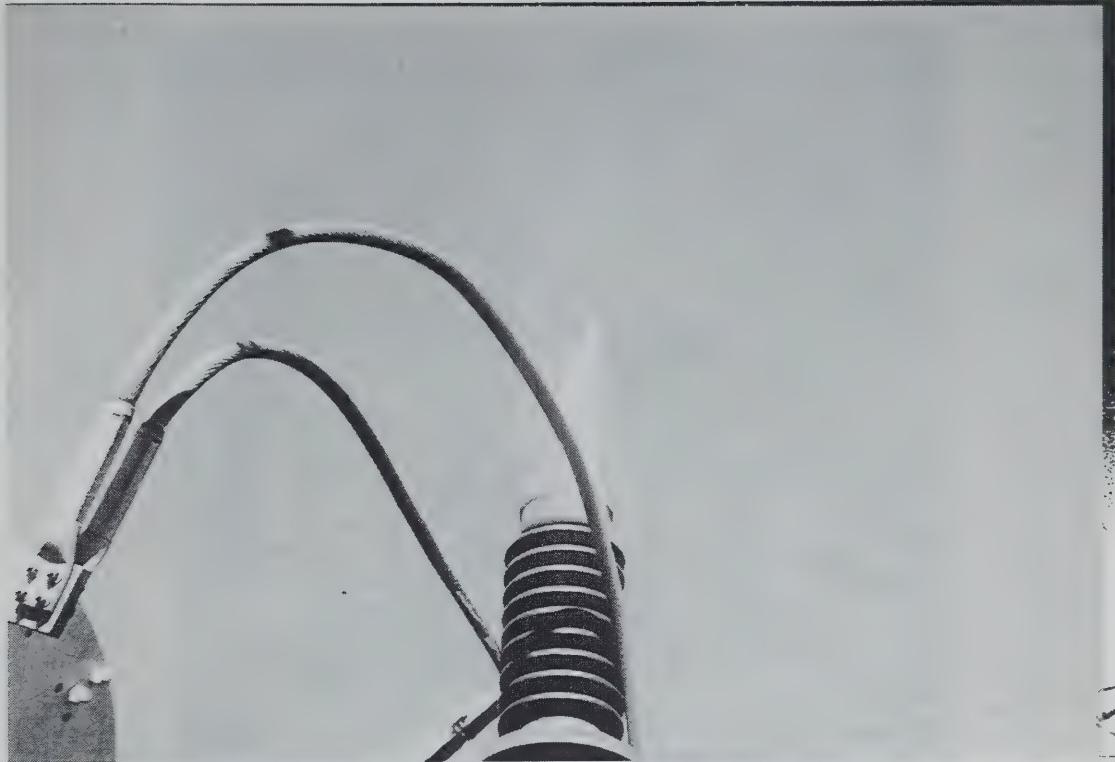
Several failures have been associated with inadequate structural design or quality assurance, Figures 5.132, 5.133, and 5.134. It is common practice in many utilities to have major structures, such as bus support structures and control houses, designed by civil/structural engineers. However, many of the minor details, such as support hardware and equipment supports, come from electrical engineering groups. Unfortunately, this has often resulted in poor earthquake performance.

Figure 5.134 A weld on a support leg failed.

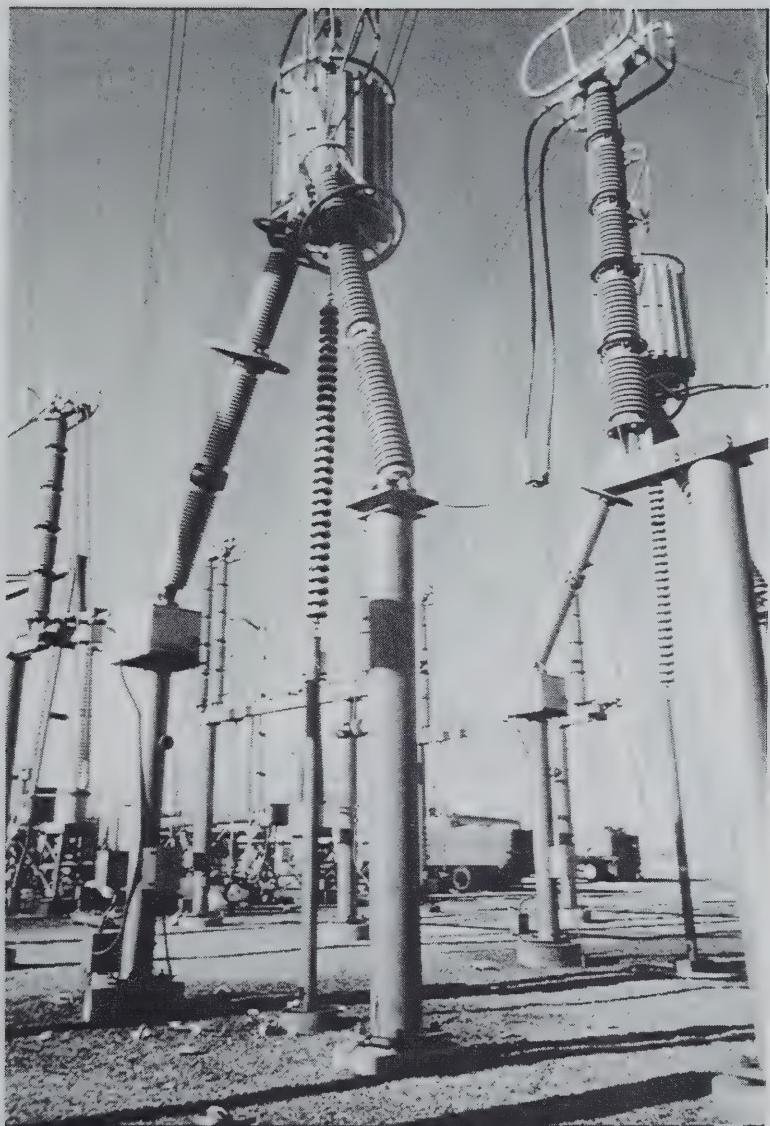
There have been several problems with suspended wave traps. Suspended wave traps with post insulators below the wave trap providing a stiff lateral restraint have often failed their lower support, Figures 5.136 and 5.137. These systems had short lengths of cable or chain between the bottom of the wave trap and the top of the lower support. The back and forth motions of an earthquake tended to generate impact loads. In these instances, the restraint failed and the wave trap itself was undamaged. Frequently the motion of the wave trap would damage equipment adjacent to it, even though the wave trap would be undamaged, Figure 5.138.

Figure 5.138 The lateral motion of the wave trap damaged adjacent equipment through interaction loads.

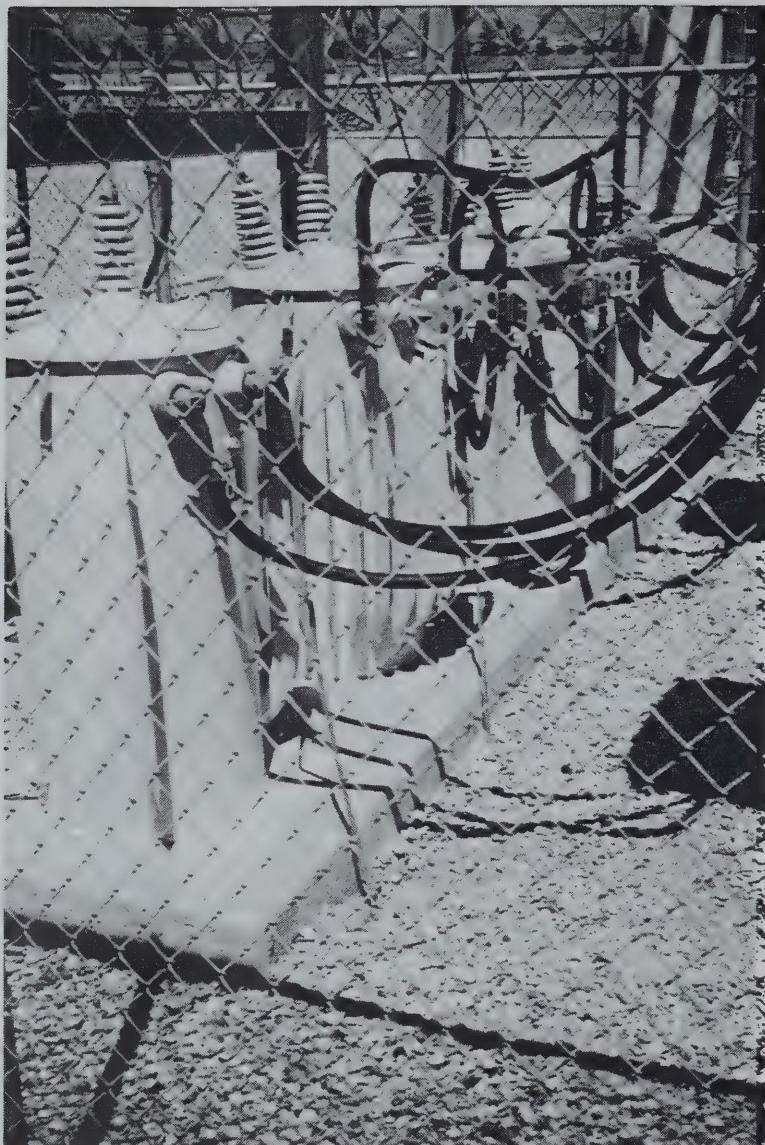
Local station power is usually obtained from tertiary windings on a power transformer, Figure 5.150. The output typically ranges from 2 kV to 16 kV. The output may go to a bus supported on a structure and eventually to a station transformer. Although small three-phase transformers may be used, it is more common to have three pole- or platform-type transformers supported on the bus-support structure, Figure 5.151, on their own support structure, or on a concrete slab surrounded by a fence, Figure 5.152. These transformers are typically poorly anchored.

Figure 5.152 One of the most common methods of supporting the station transformers is by placing them on a concrete slab at grade without anchorage.

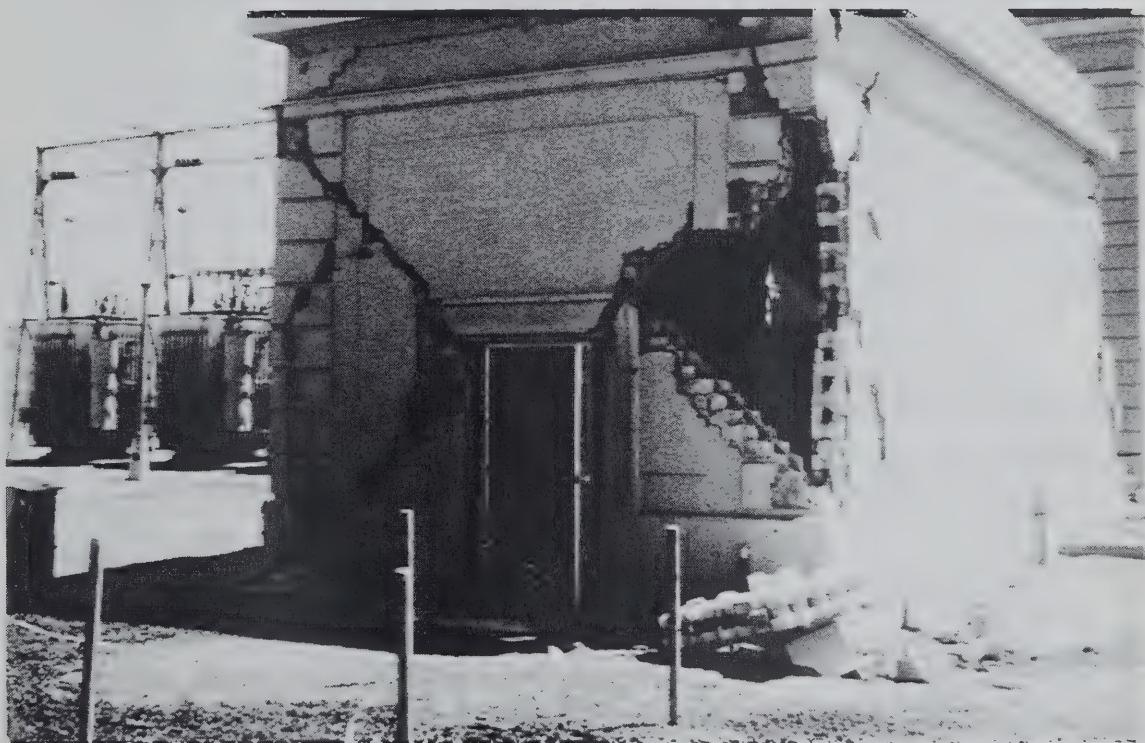
seismic requirements when they were built. Older control houses constructed with unreinforced or poorly-reinforced masonry have suffered spectacular damage, Figure 5.154. Surprisingly, the substation and the equipment in this damaged control house continued to operate. Some control houses have adequate structural frames, but have unreinforced masonry infill walls.

Figure 5.154 This unreinforced masonry control house failed spectacularly.

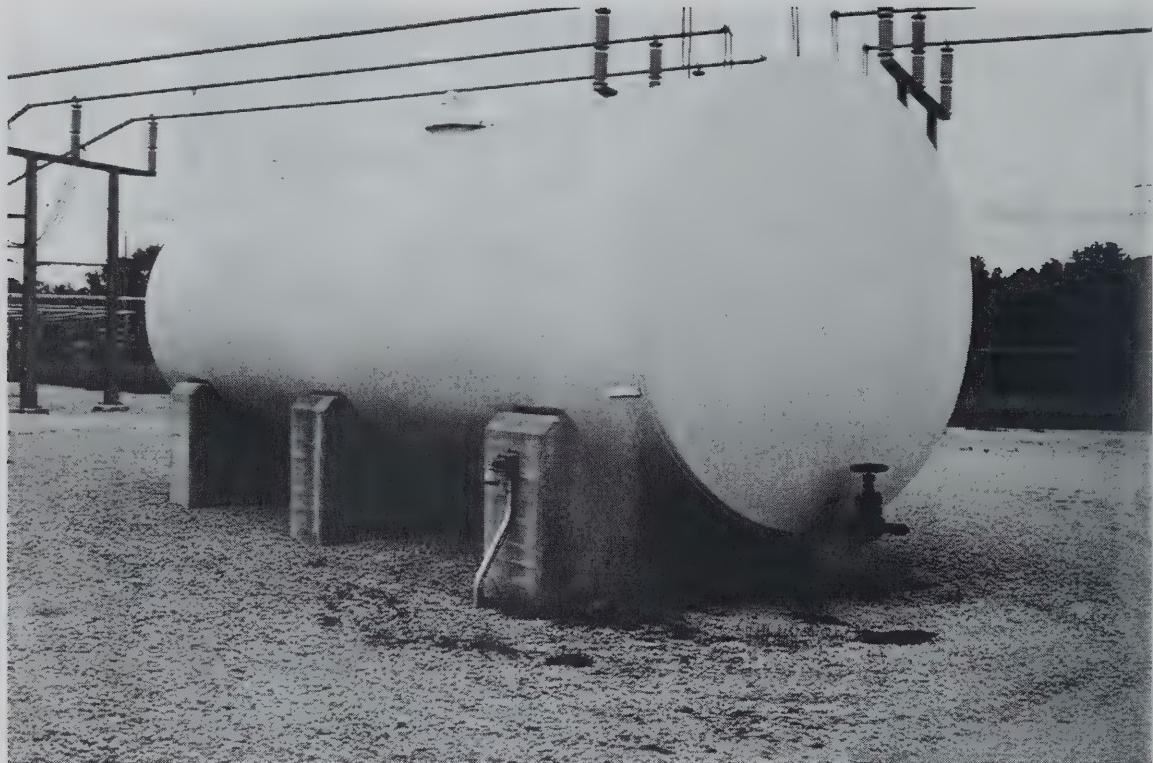
Transformers and bulk oil circuit breakers contain large volumes of oil. Many substations use oil tanks to store oil while the units are being serviced. These tanks may be unanchored or poorly anchored, Figure 5.155. Flat bottom tanks are found at some substations. The flat bottom tanks of the size typically found at substations have not exhibited seismic vulnerability observed in larger tanks.

Figure 5.155 Horizontal tanks are frequently unsecured to their cradles.

It is recommended that flat bottom tanks with a height to diameter ratio greater than 0.5 be anchored and that horizontal tanks be secured to their support cradles. Piping connections to tanks should be flexible to accommodate tank movement.

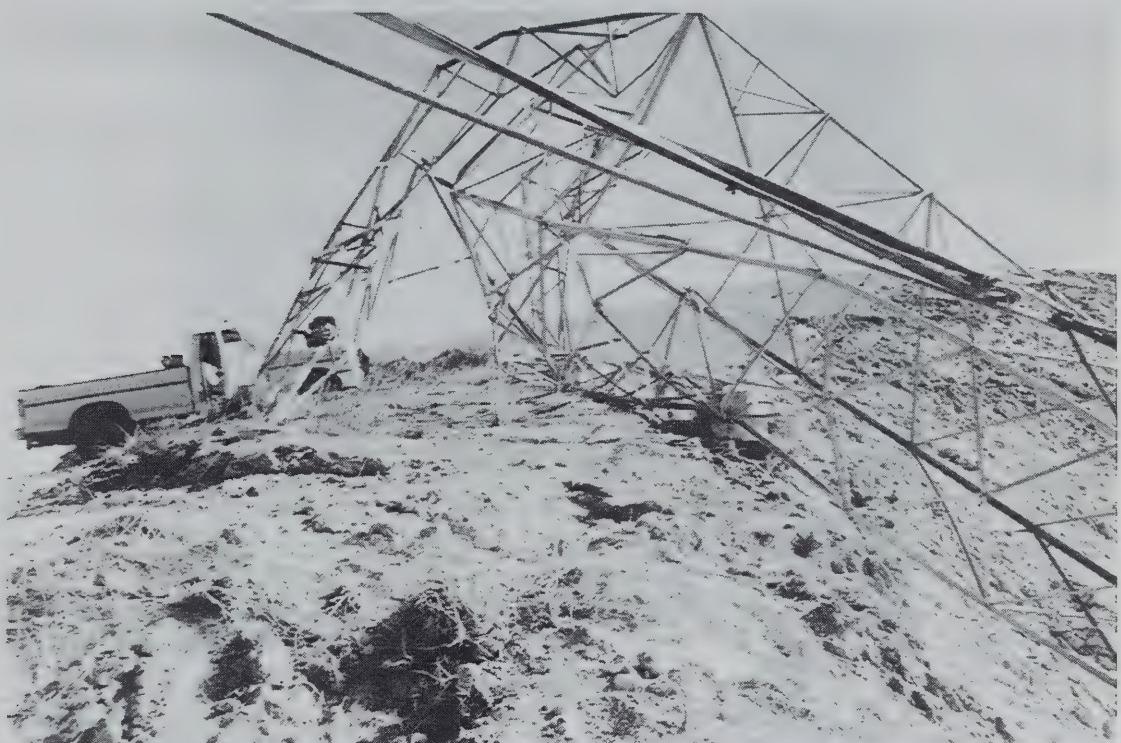
In the Northridge earthquake several towers were damaged. Damage was primarily attributed to foundation failures. Towers on ridges and crests of hills had foundations fail due to ridge shattering, Figure 6.2. In one case, when a tower failed, the two towers on each side were also pulled down by the lines. The dead-end structure discussed in Chapter 5, Substation, was similar to a transmission tower and its failure was attributed to soil liquefaction.

Figure 6.2 Collapsed transmission tower caused by ridge shattering and foundation failure.

It is advisable to carefully evaluate the foundations on transmission-line towers to be placed on steep ridges to account for ridge shattering. When possible, transmission-line towers should be set back from the edge of steep slopes. Because of the lack of performance data on transmission towers in liquefiable soils, no recommendations are given. However, foundation designs for towers near water, such as at river crossings, should consider liquefaction and lateral spreading.

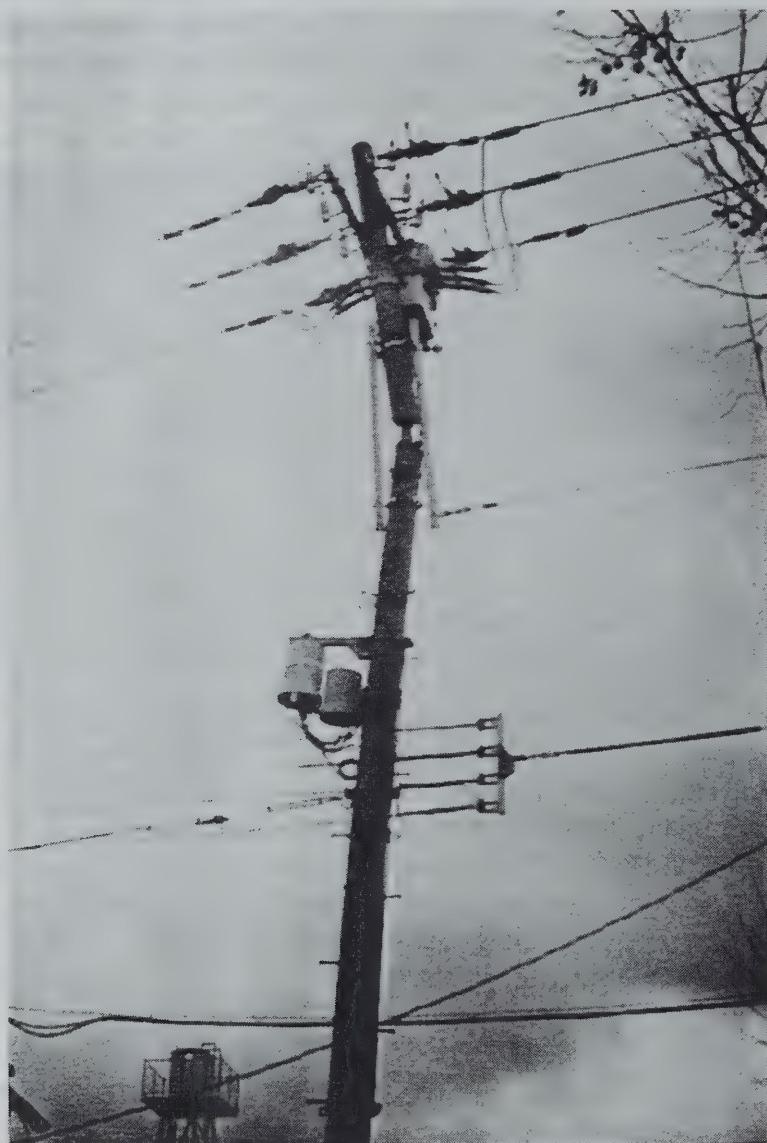
Figure 6.4 Concrete poles in Kobe, Japan, earthquake were severely damaged.

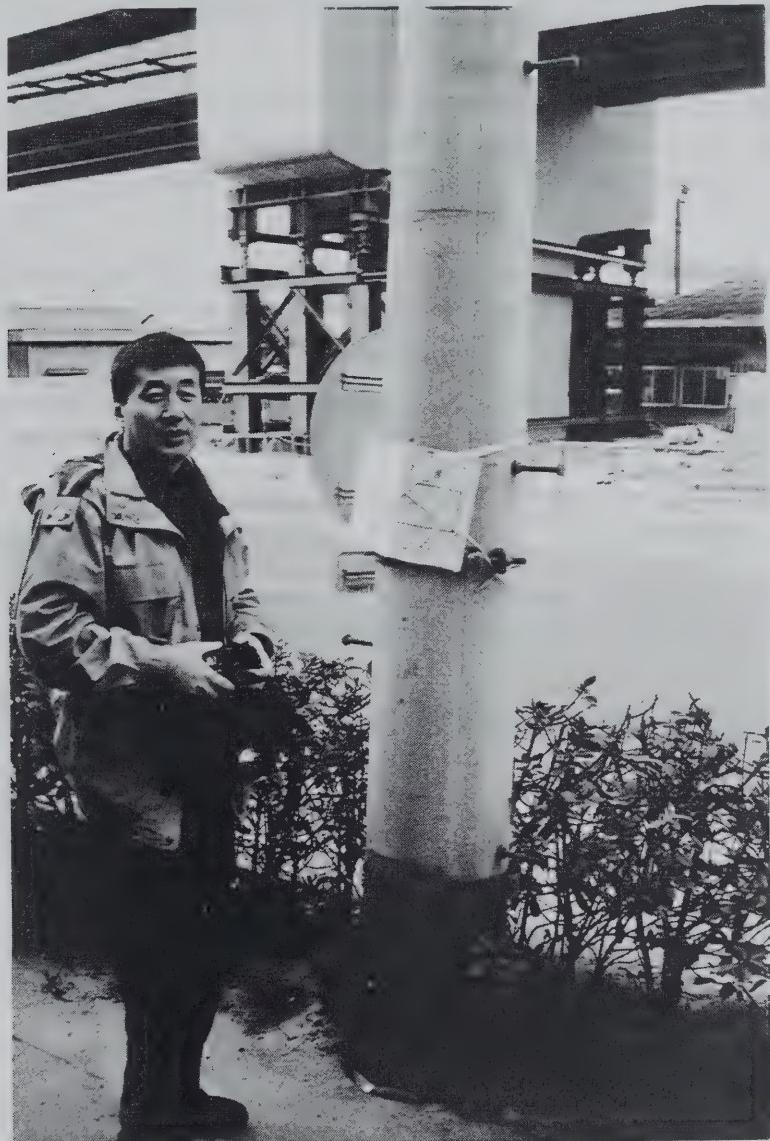
Figure 6.5 This pole sank over 5 feet when the soil liquefied.

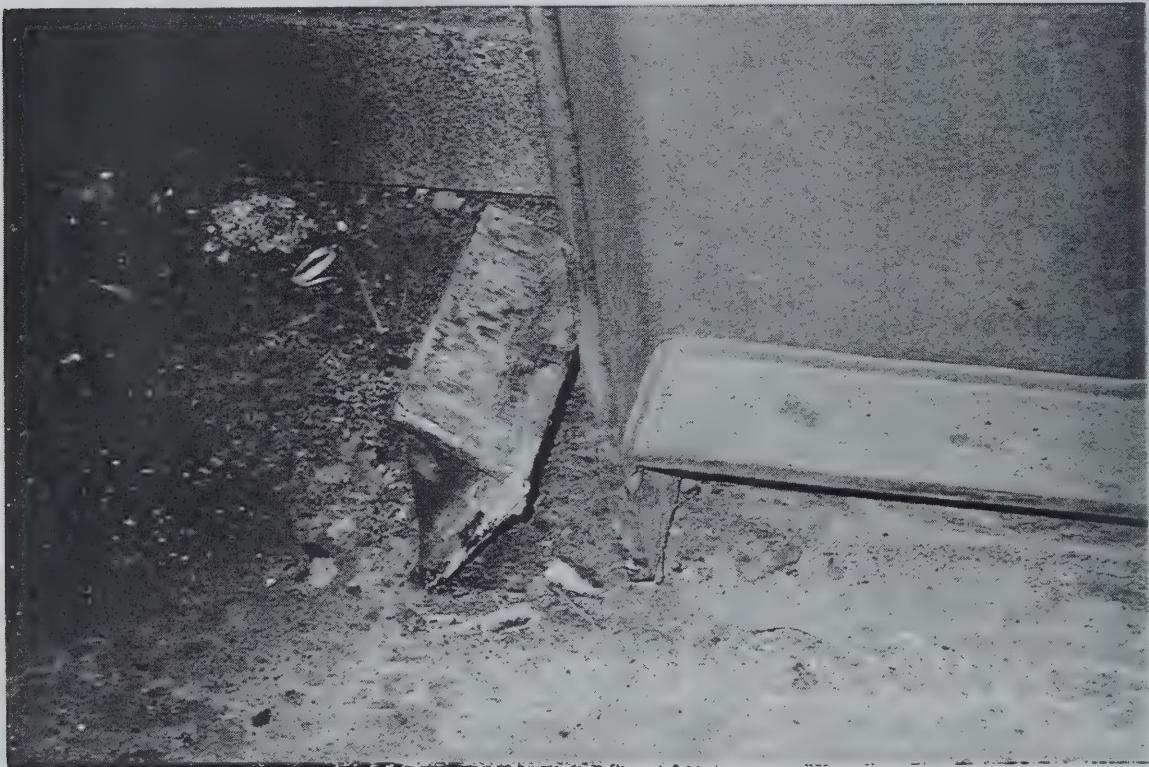
The ties that restrain a steam generator for wind loads are often inadequate for seismic loads and may fail in an earthquake. Restraints are often referred to as seismic stops, or bumpers, and may be sacrificial. That is, they may sustain severe damage but still perform their functions, Figure 7.2. They are easily repaired and they serve to protect the steam generator from sustaining severe damage.

Figure 7.2 Seismic stops are provided to limit lateral movement of the suspended steam generator. These stops may be damaged, but still perform their function.

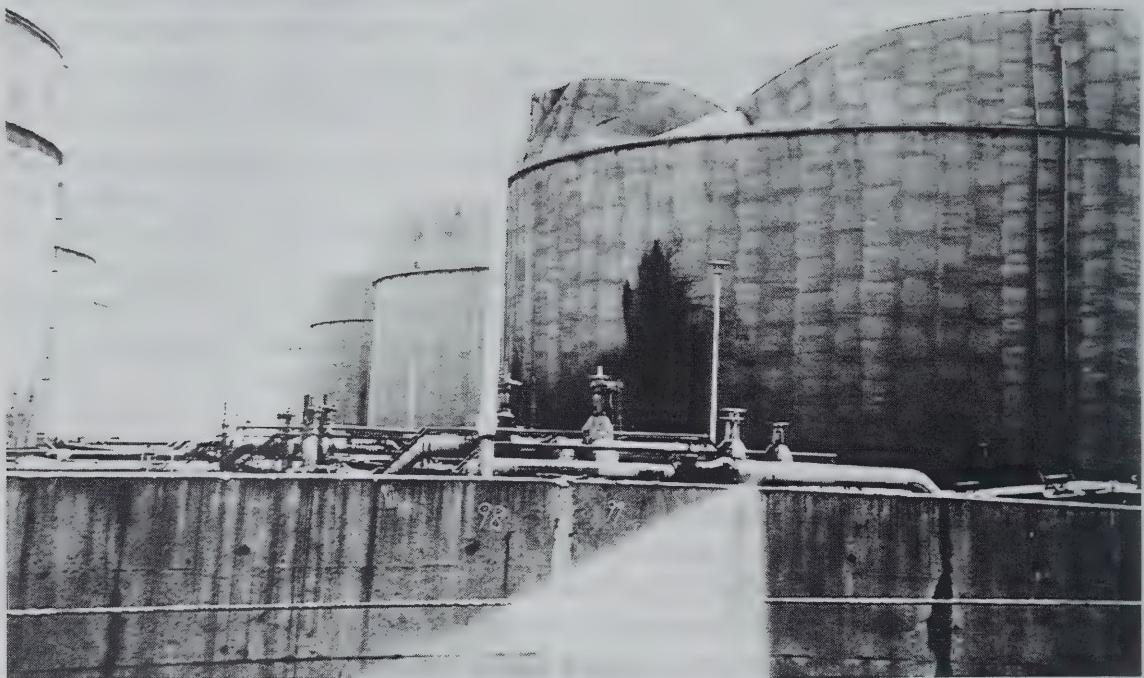
Figure 7.5 Several fuel-oil storage tanks failed and the rapid loss of contents caused the tank to buckle.
